# Analysis of the Quality Standards for Microsurfacing Treatments

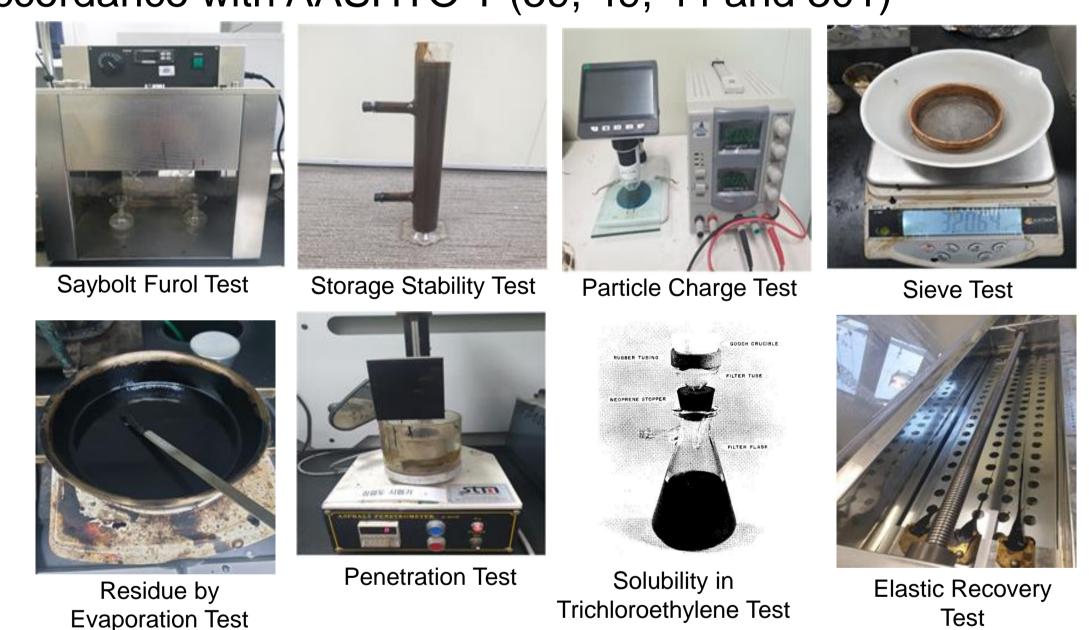
• Emulsion properties such as saybolt furol, sieve test, storage stability, particle charge, residue by evaporation, penetration, solubility in trichloroethylene and elastic recovery were tested in accordance with AASHTO T (59, 49, 44 and 301)

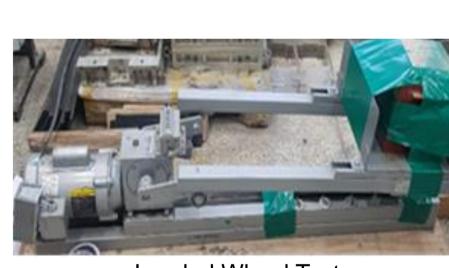
ISSA and AASHTO recommend tests such wet cohesion, wet-track abrasion, wet stripping, and loaded wheel to evaluate the quality of a laboratory produced mixture

Wet Cohesion Test V ISSA TB139

Wet Stripping Test ISSA TB 114

Wet Track Abrasion Loss Test ISSA TB 100

Loaded Wheel Tester ISSA 147

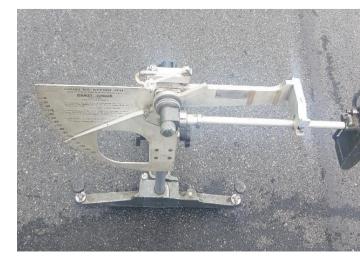
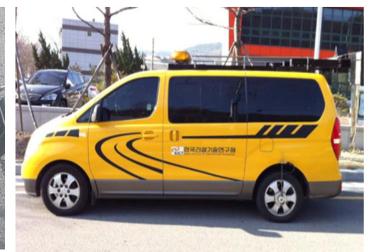
Pavement condition was evaluated considering the distresses to be addressed. Tests to access the pavement texture, the crack rates, rutting depth and the roughness were performed by a Korean agency

British Pendulum Test

PES

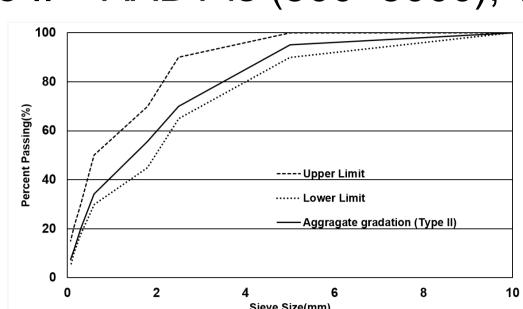
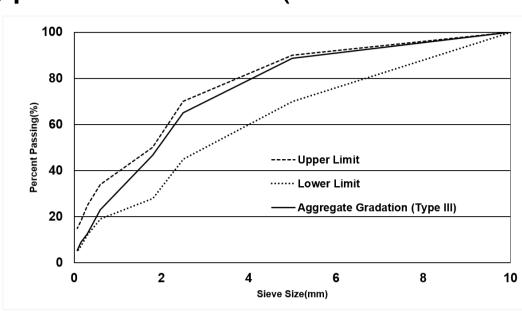
- Tested aggregates were identified as type II and type II
- Type II AADT is (500~5000), Type III AADT (more than 5000)

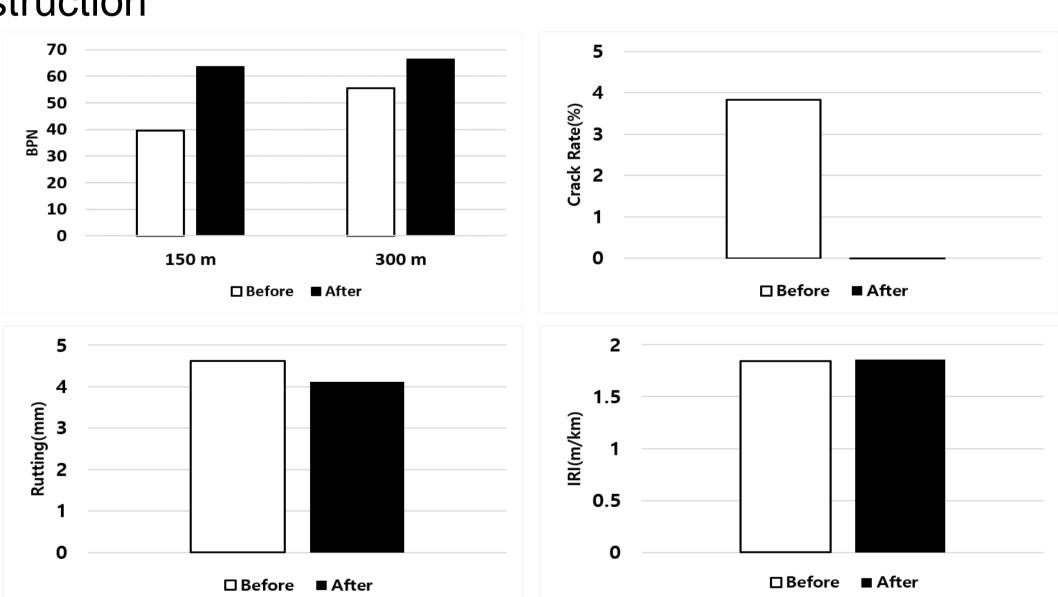
It was noticed that the surface condition was enhanced after the construction

- 1. For both lab and field materials when tested separately, some of the tested parameters did not satisfy the specified standards.
- 2. British pendulum test results increased significantly. Cracks were successfully filled, and rutting was minimized. There were no significant changes on the IRI, and its ranges are acceptable
- 3. Overall, pavement condition was enhanced, and the section will continue to be constantly maintained to achieve its maximum service life
